Ethical Aspects and Legal Liabilities of Drainage Defects in Construction

Hafizah Mohd Latif, Norazida Mohamed, Morrison Handley Schachler, Azhan Jalaludin

Drainage System Defects

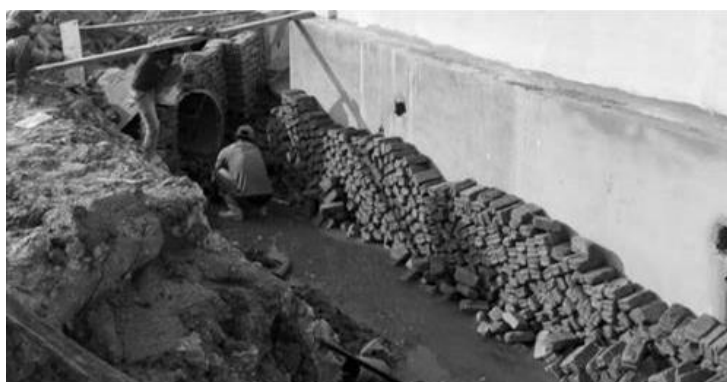
Missing rubble packing and the concrete layer, in combination, were likely causes of a roadside drain failure during the construction as shown in Figure 5.

Figure 5. Workers rectifying a defect in the roadside drain.

One possible explanation for the defect is that the weep holes were unable to function properly due to the missing rubble packing, resulting in rainwater retention in the soil. When rainwater mixed with the soil, it became over-saturated, which is particularly likely in cohesive soils, as explained by (Day, 1994). Excess moisture increased the hydrostatic pressure on the brick wall structure, which was already weak due to the lack of a concrete support base. This corroborates with VanDemark *et al* (2019) who highlighted that improper drainage could have an impact on ground stability. The drainage wall then cracked and sank before collapsing. This finding demonstrates the findings of Lee *et al* (2016) that task elimination contributes to defects.

According to site workers, lack of money has caused the contractor to reduce and eliminate the use of some drainage materials. The reason for the lack of money, however, was not clear. It is possible that the contract price was adequate but the contractor's site management was poor, that money was diverted to another project or that spending was reduced to increase profit.

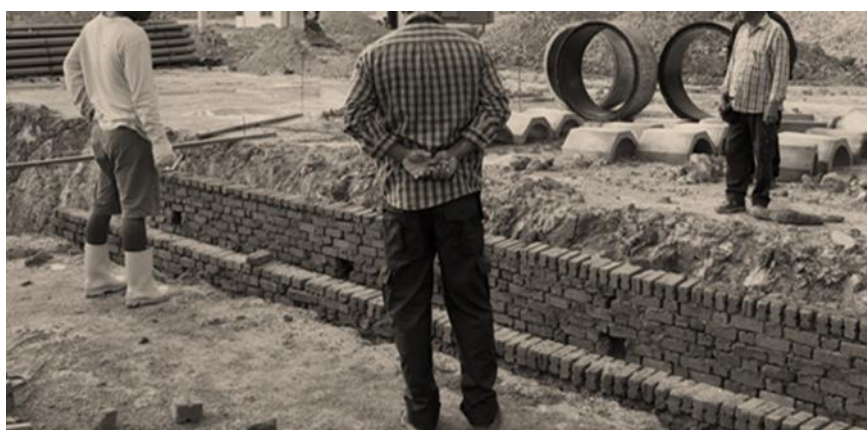
The findings demonstrated that the contractor's supervision was poor when the labours constructed the wrong type of drainage that did not comply with the as-built construction drawings. Instead of installing culvert pipes for subsurface drainage, the labours built a half round drainage system as shown in Figure 6. To reconstruct the drainage, the wrong drain walls had to be demolished with a backhoe and the area had to be cleared to allow for the installation of subsurface drains and backfilling.

Figure 6. Workers and site workers were discussing about the wrong type of drain built

The aforementioned defect required the contractor to purchase new materials as well as pay for manpower and machinery. In other words, the contractor must bear the full cost of the defect, which was not anticipated and was not included in the contract price. Previous research has shown that rectification work for defects is very expensive and has a significant impact on the contractor's financial condition and performance (e.g.: Love 2002, Mills *et al.*, 2009). Limited resources, especially money, can make it more difficult for the contractor to adhere to the specifications and as-built drawings. The contractor may have struggled to recover the additional costs due to the number and size of defects. By this viewpoint, the pressure could lead to unethical and illegal decisions, such as the missing elements described earlier. According to Paton-Cole & Aibinu (2021), contractors are unlikely to rectify defects because it reduces their profit as the expenses rise.
