Building Defects in the Coastal Environment of Malaysia: An Investigation of the Main Agents and Contributing Factors

Suriani Ngah Abdul Wahab, Nor Fatihah Rusli, Irwan Mohammad Ali, Md Yusof Hamid

Keywords: Environmental, Coastal, Building Defects, Corrosion, Saltwater, Maintenance.

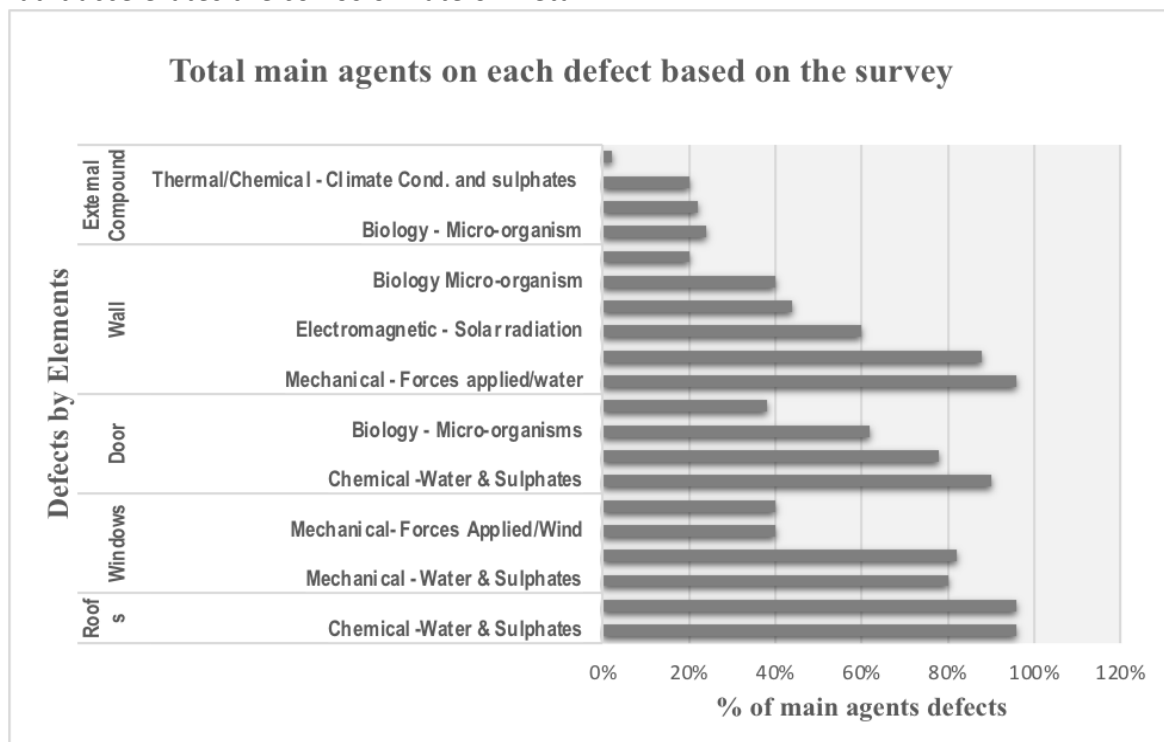
Figure 3 An assessment of the questionnaire survey on building defects and significant factors affecting coastal environments

Figure 3 and 4 shows the finding of a qualitative survey on building defects and agents that cause them. The finding on the different types of damages that can affect various building components, such as roofs, windows, doors, walls, and external compounds. For roofs, the most common causes of damage are chemical exposure to water and sulphates (96%) and mechanical forces such as wind (96%). Windows are also susceptible to chemical exposure (water and sulphates at 80%), biological damage from micro-organisms (82%), and mechanical forces such as wind (40%). Doors are prone to chemical exposure (water and sulphates at 90%), biological damage from micro-organisms (78% and 62%), and mechanical forces such as wind (38%). Walls can suffer from mechanical forces such as water (96%), biological damage from water and micro-organisms (88%), electromagnetic solar radiation (60%), and thermal climatic conditions (44%). External compounds are mostly affected by biological damage from micro-organisms (24%) and mechanical forces (22%), while thermal/chemical damage from climate conditions and sulphates (20%) is also a factor.

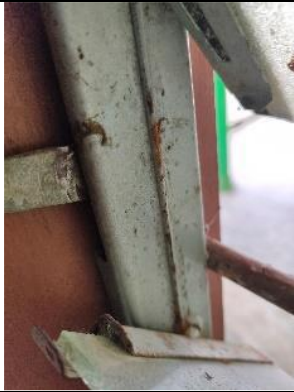
Building 1	
Louver windows that have corroded	The door hinge is corroded.

For building 1, the corrosion of louver windows and door hinges in buildings built near the seaside are subject to seawater intrusion. This is a result of the coastal area's wind direction and speed (salt air) affecting the building. The corrosion may have weakened the structural integrity of the affected parts, potentially compromising the safety and security of the building. It is recommended to replace the corroded parts with materials that are more resistant to corrosion in a coastal environment.

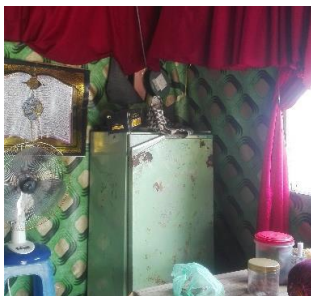
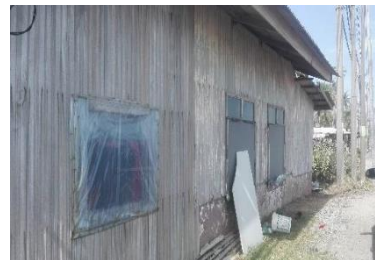
Electricity equipment and door hinge corrosion Wooden wall decay and sticky surfaces on the walls (sea salt).

Meanwhile for Building 2, the corrosion of electrical equipment and door hinges is caused by the exposure of saltwater to electrical appliances in the building. This form of corrosion occurs when two different metals with physical or electrical contact are immersed in a common electrolyte (such as salt water) or when a metal is exposed to different concentrations of electrolyte. When saltwater comes into contact with electrical equipment and door hinges, it can accelerate the corrosion process due to the presence of chloride ions. The seawater that condenses on building elements will finally evaporate, but the salt in the water will remain. This also results in the decay of the timber wall and its surface to be sticky. The sticky surfaces may be due to the salt in the air, which can accumulate on surfaces and make them difficult to clean. It is recommended to repair or replace the affected parts and use materials that are more resistant to corrosion and decay.

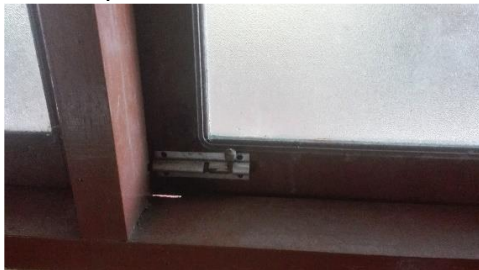
The metal part is rusted.

Wooden structure deterioration and crack

Rust on the metal component and decay of timber structure can be found in Building 4. In the coastal area, the quantity of moisture present in the air is higher than in the deserts. Hence, rusting of iron objects is faster. Biological damage to above-water parts of waterfront structures is caused directly or indirectly by the activity of fungi and insects that utilize wood for food or nesting material. The rust on the metal part can compromise its strength and structural integrity, while the deterioration and crack on the wooden structure may be a result of rot and decay caused by the high levels of humidity and moisture in the air. It is recommended to replace the rusted metal part with a more resistant material and repair or replace the deteriorated wooden structure to ensure the safety and stability of the building.
