Effect of Rubberised Engineered Cementitious Composite (R-ECC) Application as Retrofitting Material on the Structural of Reinforced Concrete Beam-Column Joint Subjected to Static and Cyclic Loading

Nor Wahida Azmin, Mohd Ikmal Fazlan Rozli@Rosli, Kay Dora Abd Ghani, Atiqah Abdul Aziz, Noorliyana Zakaria, Nor Asyiqin Jafri

Published Date: 26 September 2024

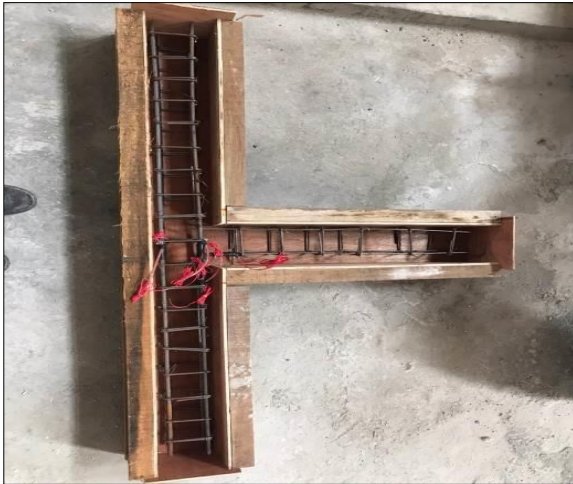
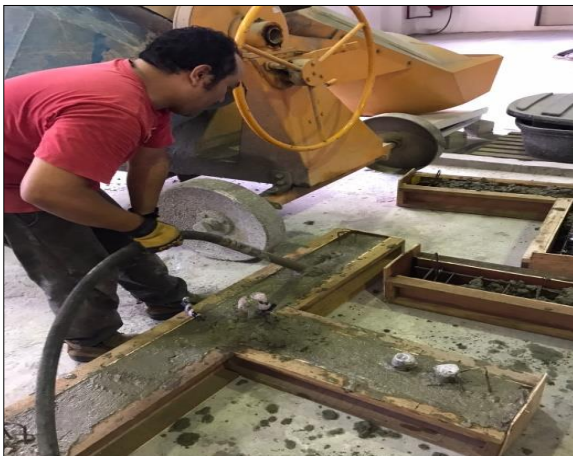
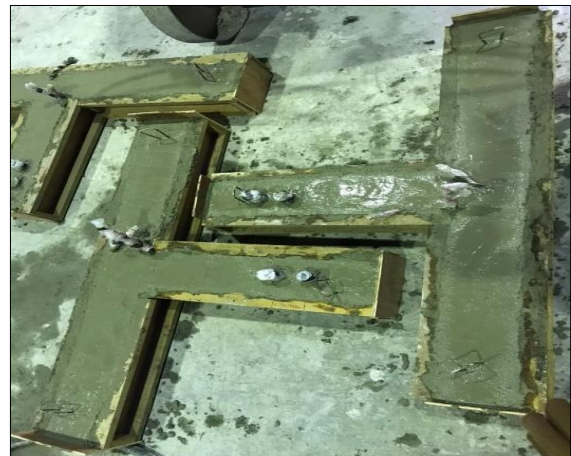
Figure 3. Casting Process of Beam-Column Joints

The beam-column joint was shaped using mould or formwork. The placement of reinforcement positioned correctly, with a clear covering, and with enough space inside the formwork, as shown in Figure 3(a). Tie wires or rebar chairs were used to hold the rebars in

place to maintain the necessary concrete cover. Subsequently, the blended concrete was gradually poured into the formwork, ensuring a uniform flow to prevent segregation as shown in Figure 3(b). Figure 3(c) shows the vibrators were among the appropriate tools used to compact the concrete and remove air spaces. The entire of the beam's volume was guaranteed to have proper compaction. To achieve the desired finish, the concrete's exposed surface was smoothed with a trowel or float. After that, the samples were cured for 28 days as shown in Figure 3(d), and adequate moisture during the curing process was maintained until the day of testing.

(a) Installing Reinforcement Bars in The Formwork

(b) Concrete pouring into the formwork

(c) Vibrating Concrete Process

(d) Casting and Curing process of R-ECC

Next, the study proceeds to casting the models of concrete. The concrete grade used in this experiment was G30. Design and preparation came first in the overall process for casting a beam-column joint. Based on the demands of the structural design, the needed dimensions, reinforcing details, and load-bearing capacity of the beam were determined. Figure 3 shows the casting process of the beam-column joint.

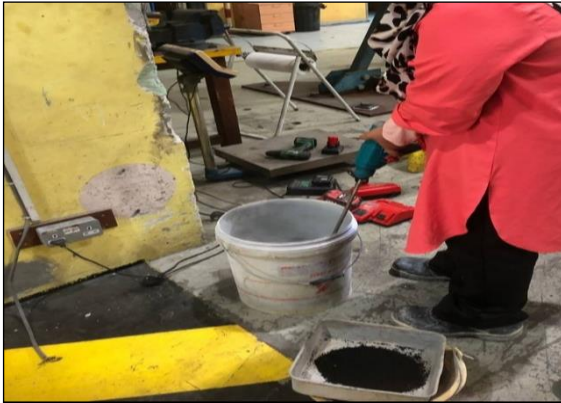
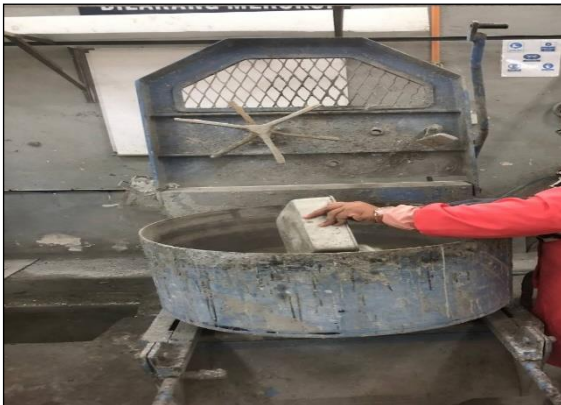
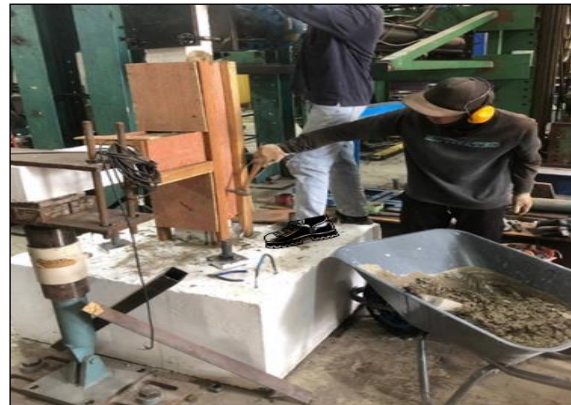
Figure 5. Experimental Work of Beam-Column Joints

(c) Roughness The Surface Using a Sledgehammer

(d) Roughness The Surface Using Impact Hammer

(e) Installing Wire Mesh

(f) Sprayed The Sample with Water to Remove Dust

(g) Mix for Base Lining Using Concrete Mixer

(h) Applied Base Lining with 10 mm of Thickness at The Sample

(i) Mix for R-ECC Using Concrete Mixer Pan

(j) Install Formwork and Fill RECC into Formwork with 20 mm of

Firstly, the dry components (fly ash, sand, crumb rubber, and composite Portland cement) were added to the pan mixer and blend together. The superplasticiser was added and mixed with half of the water. The remaining water and polyvinyl alcohol (PVA) fibres were gradually added and mixed until a homogenous and uniform mixture was achieved. The mixtures were then cautiously poured into the prepared moulds.

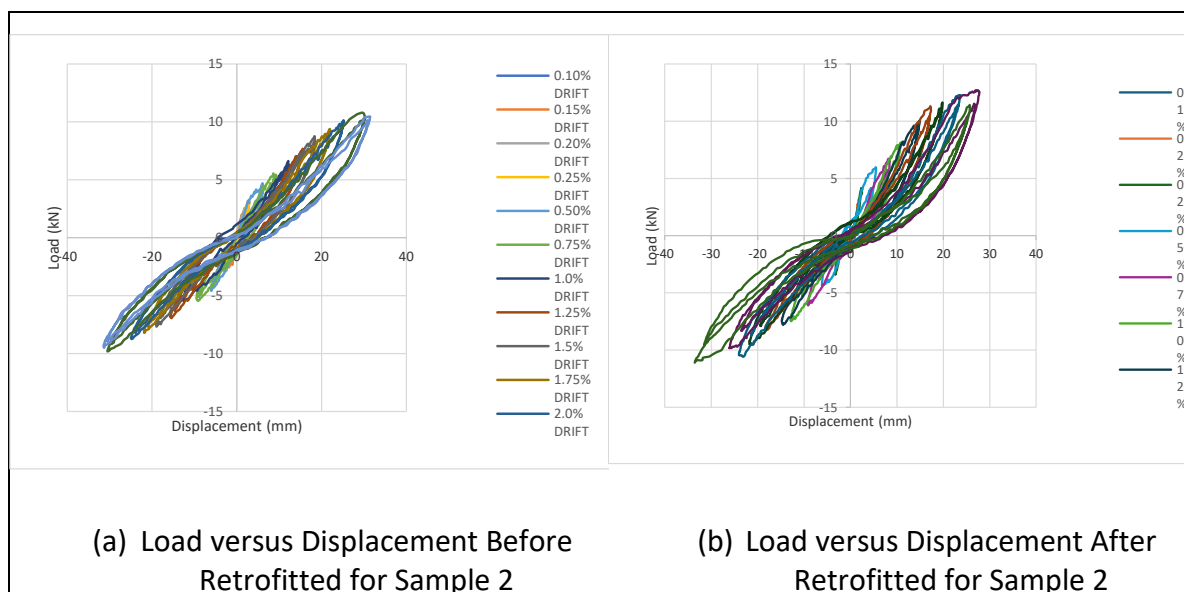
Figure 6. Load versus Displacement Before and After Retrofitting with R-ECC

The load-displacement curves show a linear relationship between load and displacement in all specimens. Figure 6(a) and Figure 6(b) show load-displacement graphs before and after retrofit for sample 2. In general, samples that had R-ECC reinforcements were able to reach larger displacement levels than samples that did not. Under cyclic loads, the behavior of beam-column joints with R-ECC reinforcement was examined in the study. Specimens were loaded until capacity was attained and the yield point was reached.

- The load-displacement behavior of the retrofitted beam-column joints exhibited enhanced energy dissipation and increased resistance to crack initiation and propagation compared to the non-retrofitted beam-column joints.
- The beam-column joint strengthened with wire mesh and retrofitted with R-ECC improved deformation capacity and ductility, indicating enhanced energy dissipation capacity and seismic performance.

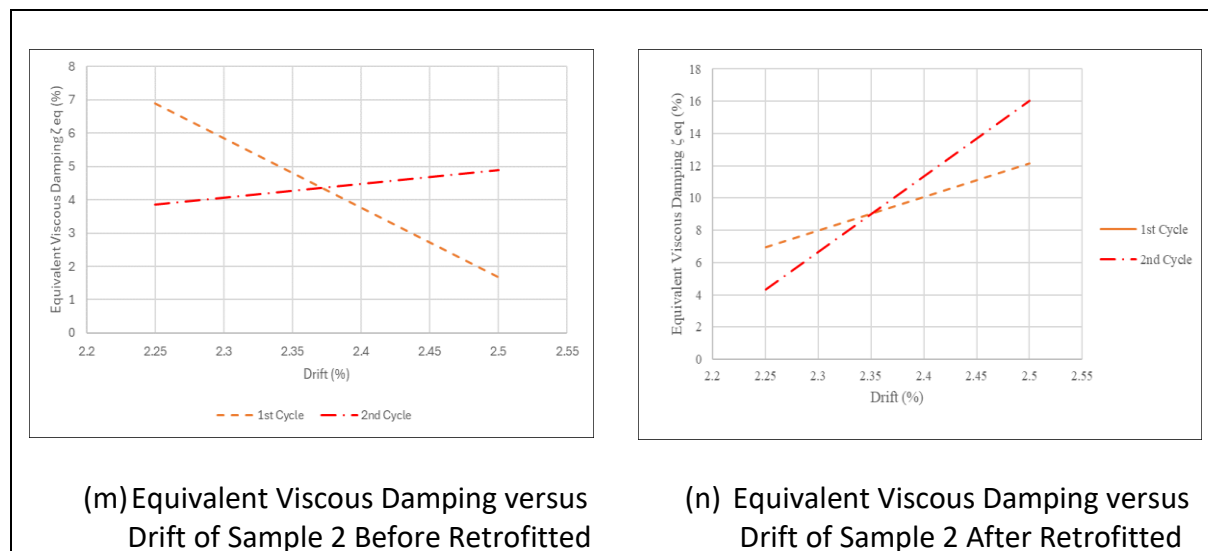
Figure 7. Equivalent Viscous Damping versus Drift of Sample 2 Before and After Retrofitted with R-ECC

The energy dissipation capacity and damping characteristics of sample 2 were enhanced by the retrofitting of R-ECC. Based on the equivalent viscous damping result shown in Table 3, Table 4, and Figure 7, the joint exhibited marginally less damping in the first cycle compared to the second, which means that it took in less energy during the initial shock prior to retrofitting. On the other hand, retrofitting resulted in consistently higher damping values for the second cycle than the first, suggesting better capacity for dissipating energy. An example of this improvement is provided by comparing the equivalent viscous damping values at drift levels before and after the retrofit. It is evident from these modifications that the retrofitting procedure enhanced the joint's energy dissipation capacity, a crucial factor in enhancing its seismic performance.
